UNITED STATES DISTRICT COURT
 FOR THE EASTERN DISTRICT OF NORTH CAROLINA
 WESTERN DIVISION
 No. 5:15-CR-62-H
 No. 5:15-CR-67-H
 No. 5:15-CR-68-H

UNITED STATES OF AMERICA)	
)	
v.)	JOINT FACTUAL STATEMENT
)	
DUKE ENERGY BUSINESS SERVICES LLC)	
DUKE ENERGY CAROLINAS, LLC)	
DUKE ENERGY PROGRESS, INC.)

I. INTRODUCTION

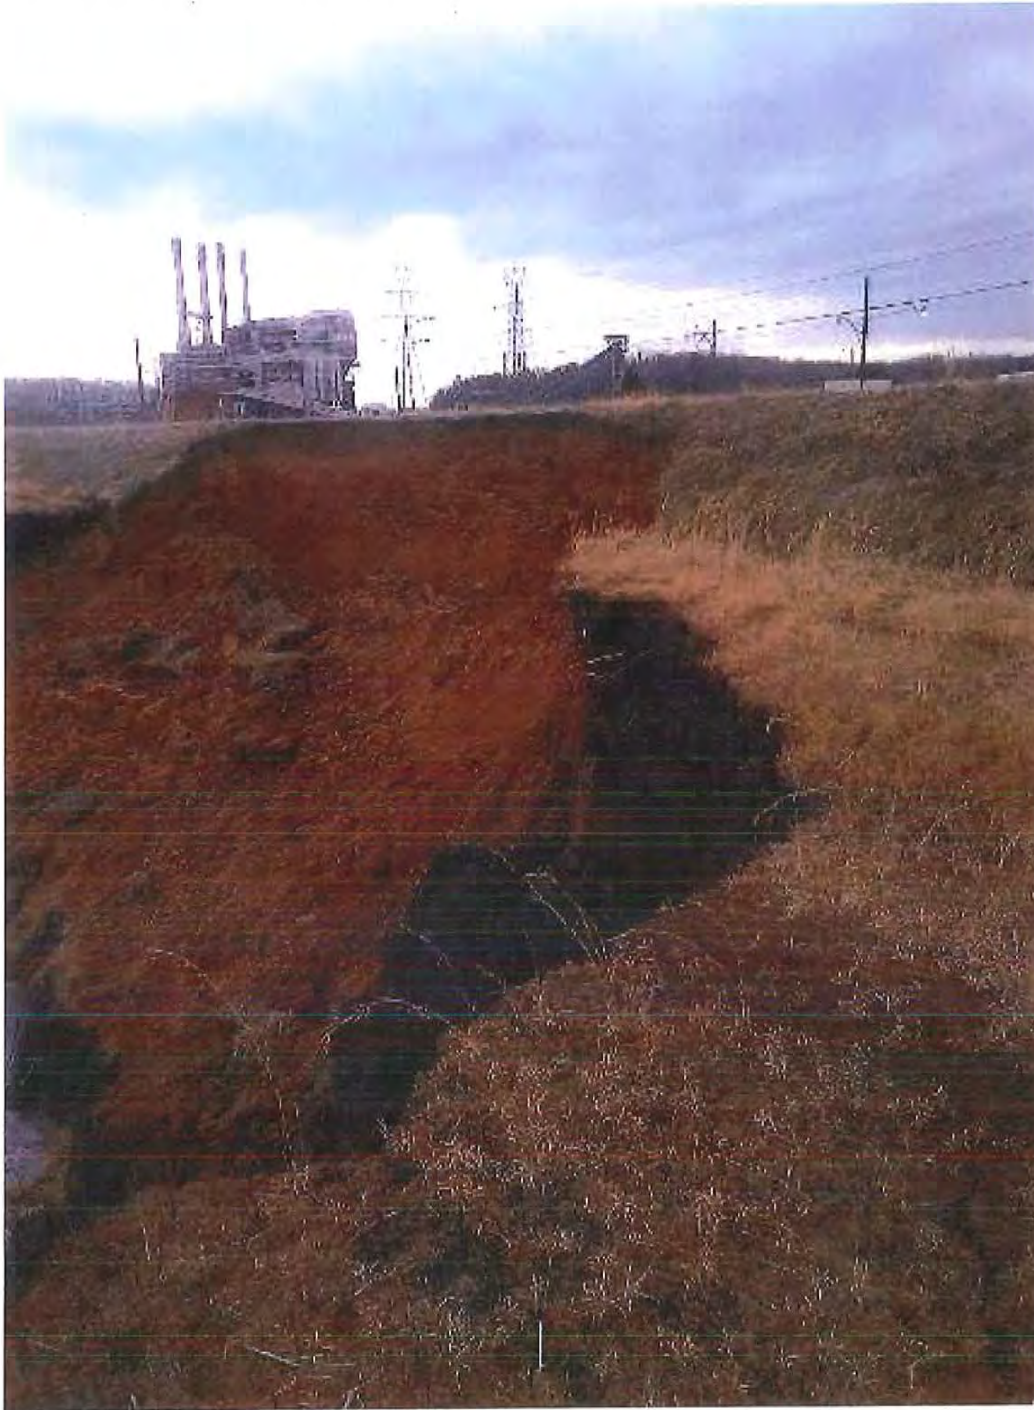
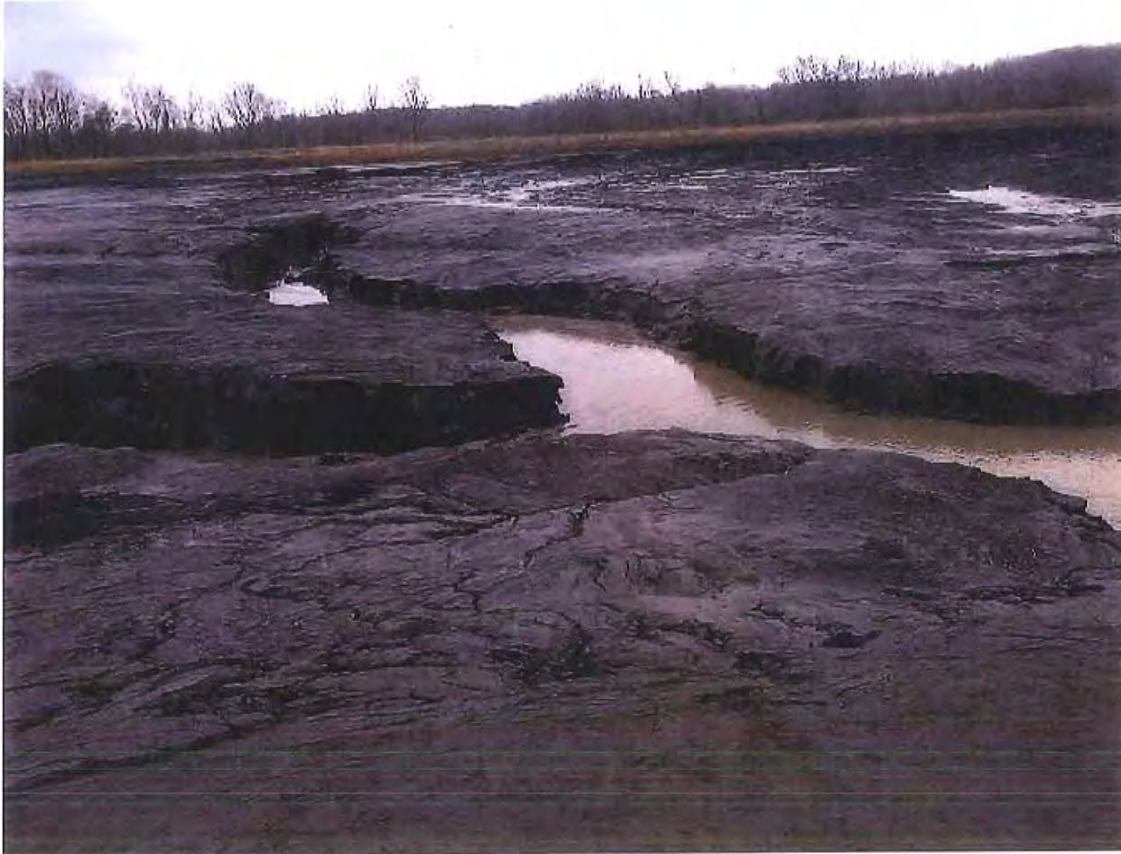
Photograph 1. Photograph of DAN RIVER coal ash basin during spill, attached to 2/2/2014, 3:49 p.m. e-mail from Duke Energy Business Services employee.

81. On February 2, 2014, a five-foot long elbow joint within the sixty-year-old corrugated metal section of the 48-inch pipe under the Primary Ash Basin at DAN RIVER failed, resulting in the release of coal ash wastewater and coal ash into the Dan River.

life for CMP under similar conditions. Ultimately, the combination of the corrosion and the weight of the coal ash basin over the elbow joint caused it to buckle, fail, and be pushed through the end of the 48-inch stormwater pipe into the Dan River.

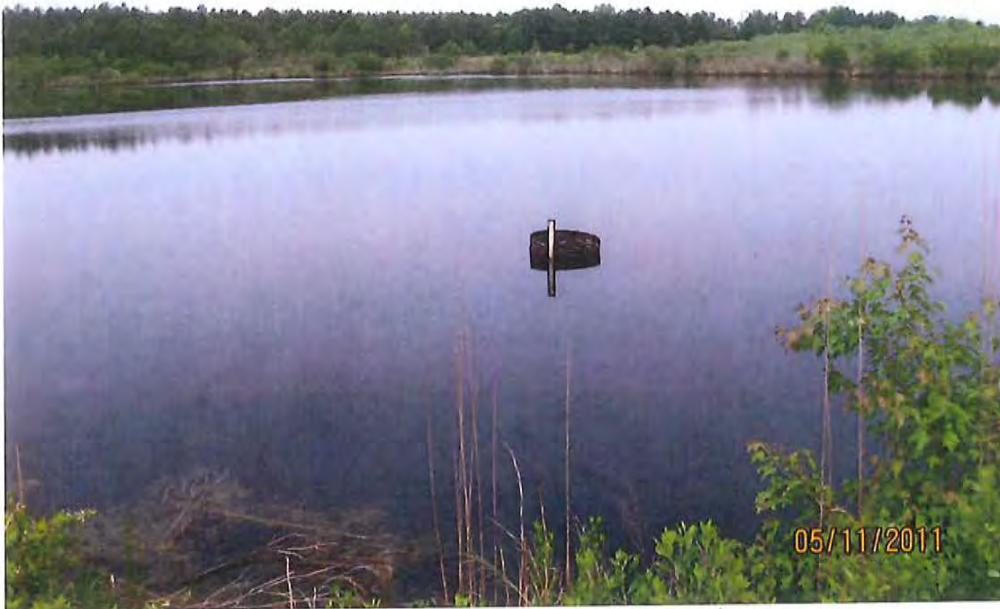
Photograph 5. Riser in CAPE FEAR 1978 coal ash basin from 2012 Five Year Independent Consultant Report.

110. The 2012 Five-Year Independent Consultant Report, produced on January 26, 2012, by Engineering Firm #4, noted that the skimmer located at the top of the riser in the 1978 ash basin was corroded and tilted. The skimmer was designed to

113. Annual inspection reports for 2012 and 2013 also reported that the riser in the 1978 ash basin was damaged, deteriorated, and tilted. The annual reports recommended that DUKE ENERGY PROGRESS/Progress Energy Carolinas replace or repair the skimmer on the riser in the 1978 ash basin.

114. At no time from January 26, 2012, through March 2014 did DUKE ENERGY PROGRESS/Progress Energy Carolinas repair or replace the skimmer on the riser in the 1978 coal ash basin.

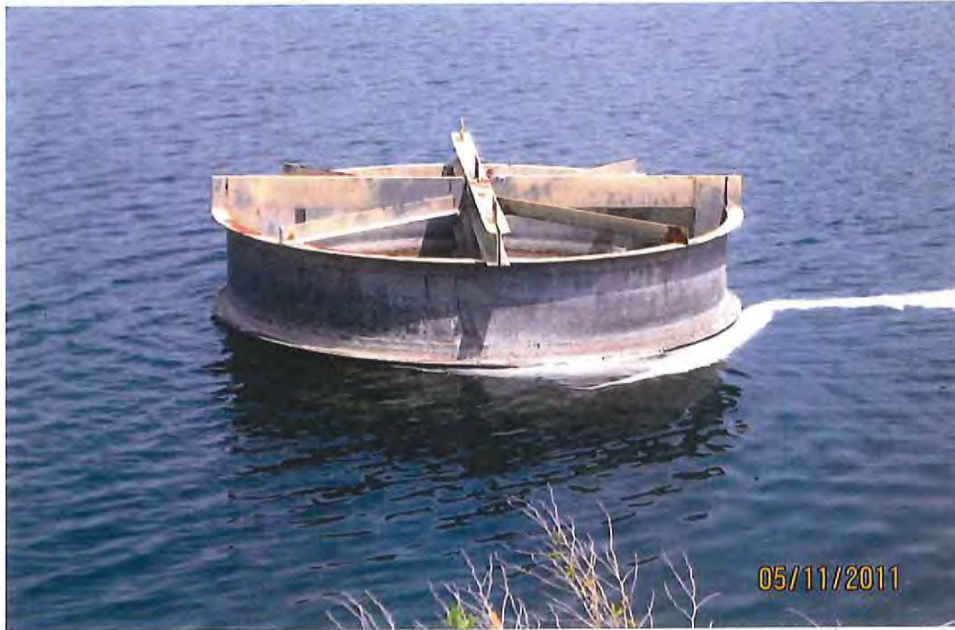
Photograph 7. Riser in CAPE FEAR 1985 coal ash basin from 2012 Five Year Independent Consultant Report.

106. The 2008 annual inspection report described the condition of the risers in the 1978 and 1985 coal ash basins as "marginal" and estimated that the risers were "likely to develop problems" in two to five years from the date of the report. The report further recommended that DUKE ENERGY PROGRESS/Progress Energy Carolinas perform its own inspections of the risers in

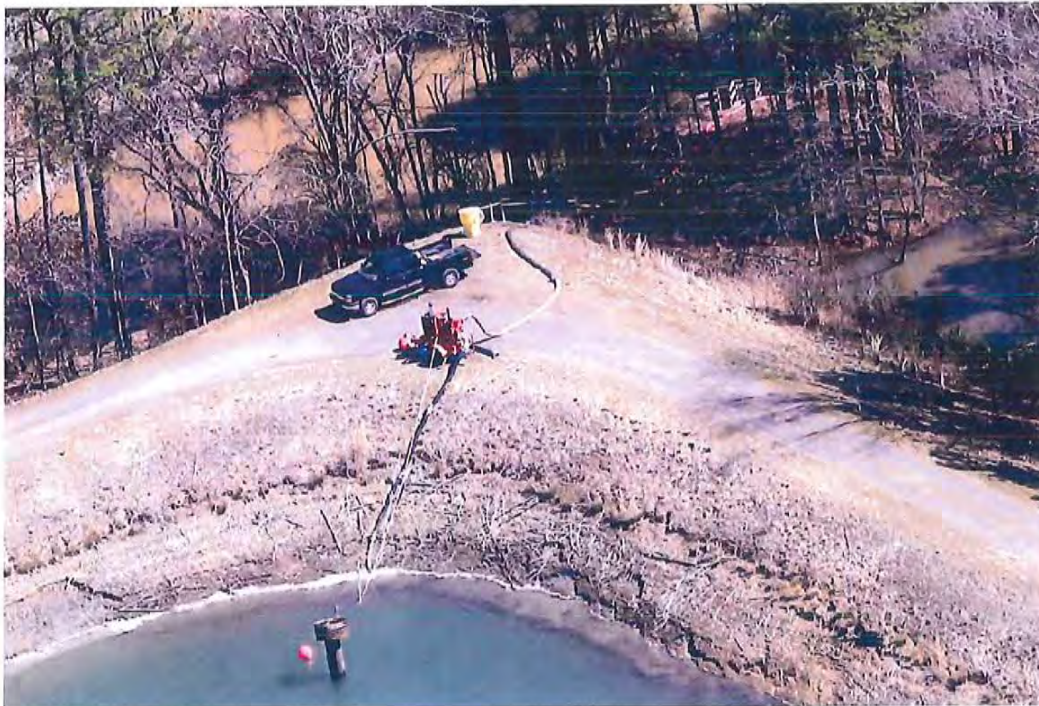
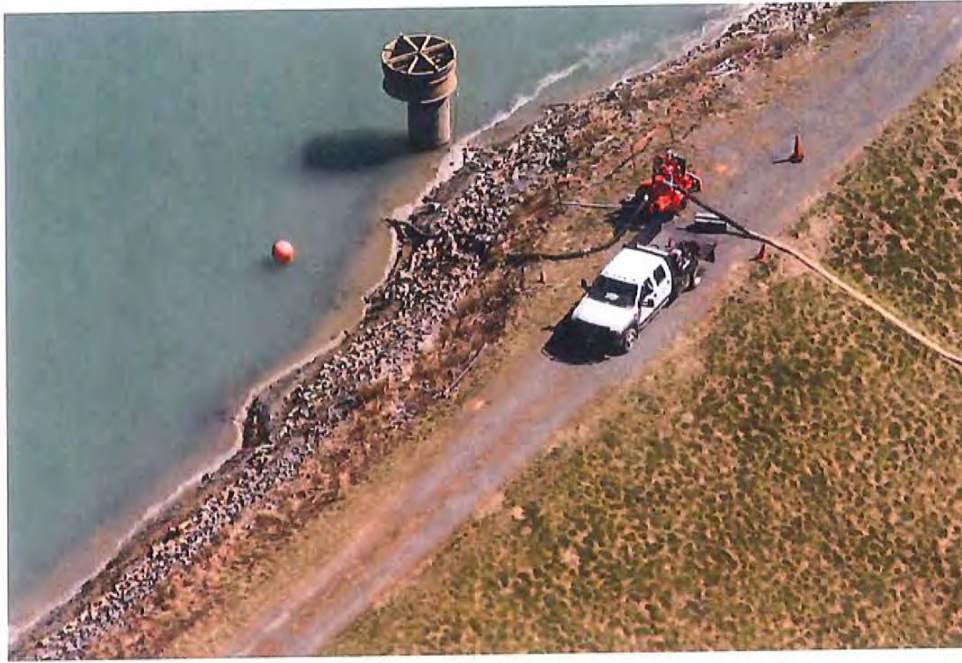
Photograph 8. 3/11/14 aerial photograph of CAPE FEAR 1978 coal ash basin with Godwin pump and truck.

127. On or about March 11, 2014, DENR officials from both the DWR and the Division of Mineral and Land Resources visited CAPE FEAR to perform an inspection. The DENR officials were accompanied by several DUKE ENERGY PROGRESS and DUKE ENERGY BUSINESS SERVICES employees during their inspection. DENR observed the Godwin pumps at the 1985 and 1978 ash basins along with obvious signs of a significant drop in the water level in the coal ash basins and disturbances in the surface of the coal ash in the basins. (See Appendix, Photographs 8 - 10).

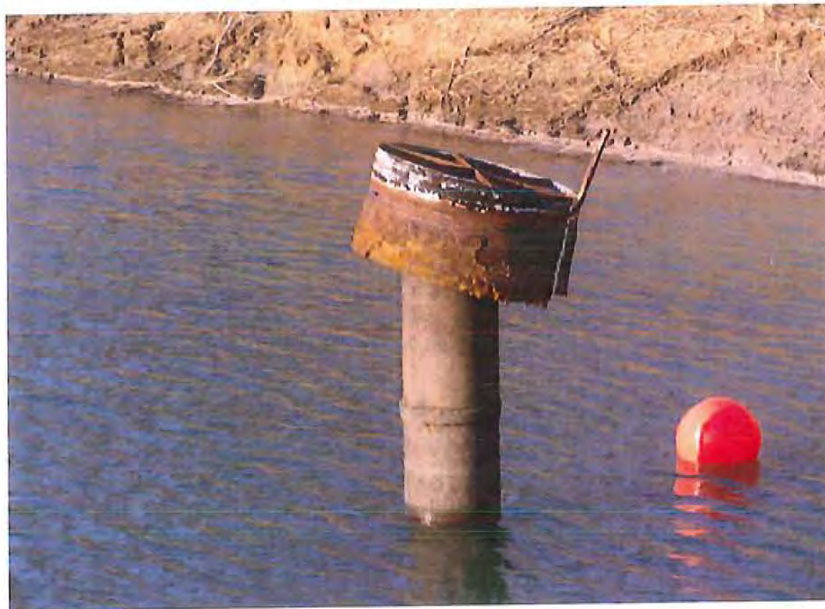
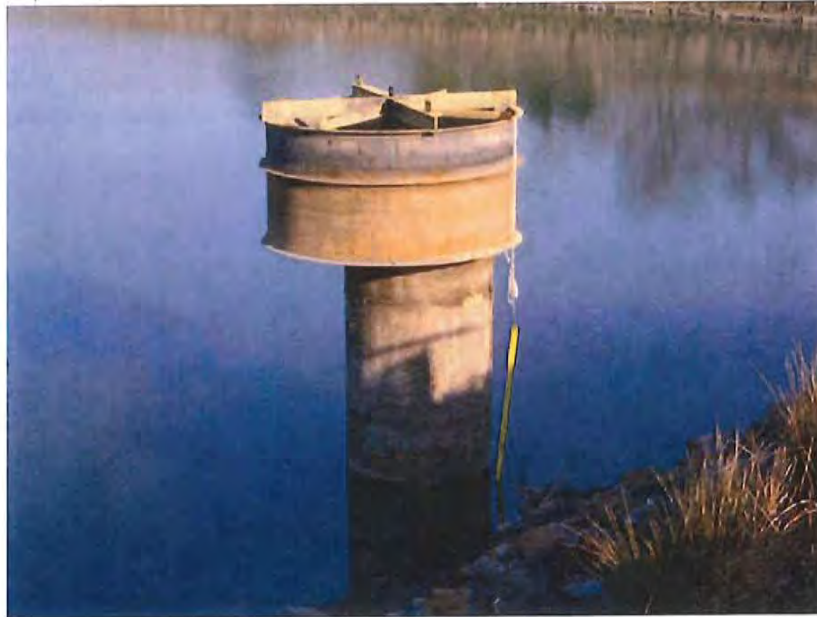
Photograph 11. 3/19/14 photograph of CAPE FEAR 1978 coal ash basin riser, prior to repair work.

for contractors performing repair work. DUKE ENERGY PROGRESS and DUKE ENERGY BUSINESS SERVICES employees knew that the leaks in the risers were likely being caused by cracks or failures in the grout between the concrete pipe sections that were underwater. The employees did not know how far underwater the leaks or grout failures were or how many sections of the pipe would need repair. Because the risers were filled with air but surrounded by water, underwater repair of the risers could be hazardous to the divers due to a phenomenon known as "differential pressure." DUKE ENERGY PROGRESS and DUKE ENERGY BUSINESS SERVICES employees believed that removing the standing water from the 1978 and 1985 basins to at or below the level of the leaking portions of the risers would eliminate the risk from differential pressure.

the 1985 coal ash basin, the visibility in one area was "next to nothing." The visibility was negatively impacted by turbidity and debris in the pipe. The contractor observed a "slow trickle" of water intruding into the riser in the 1978 coal ash basin. At the time of the camera inspections, the water level in both coal ash basins had already been lowered below the uppermost joints of the risers and, thus, below the level of some of the leaks.

131. On or about March 19 and 20, 2014, employees and agents of the underwater pipe repair contractor replaced and resealed the grout between the concrete pipe sections of the risers in the 1978 and 1985 coal ash basins. **(See Appendix, Photographs 11 through 14).**

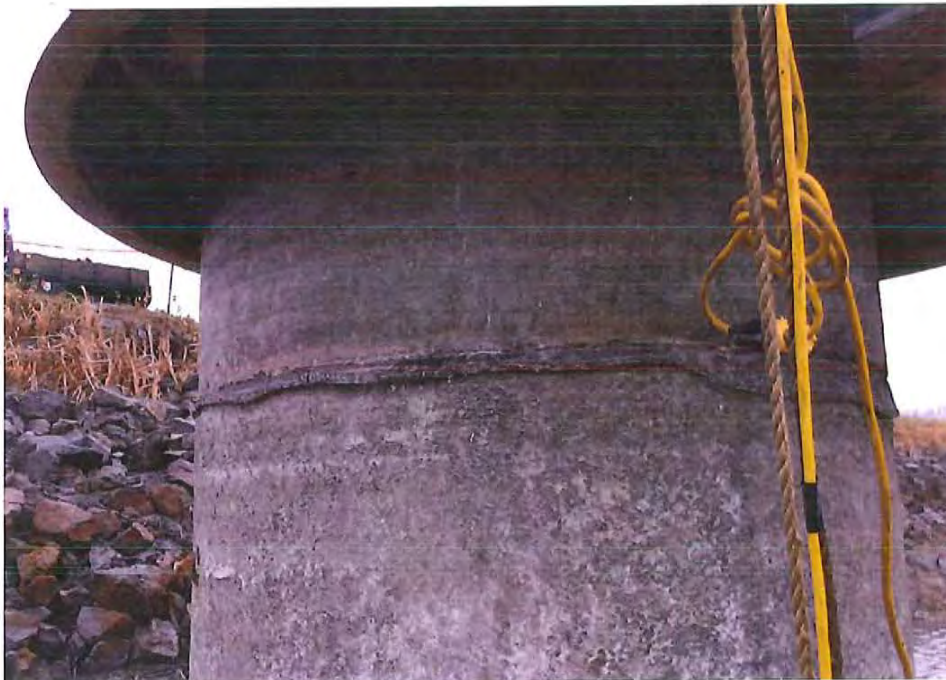
Photograph 13. 3/19/14 photograph of old grout on CAPE FEAR coal ash basin riser.

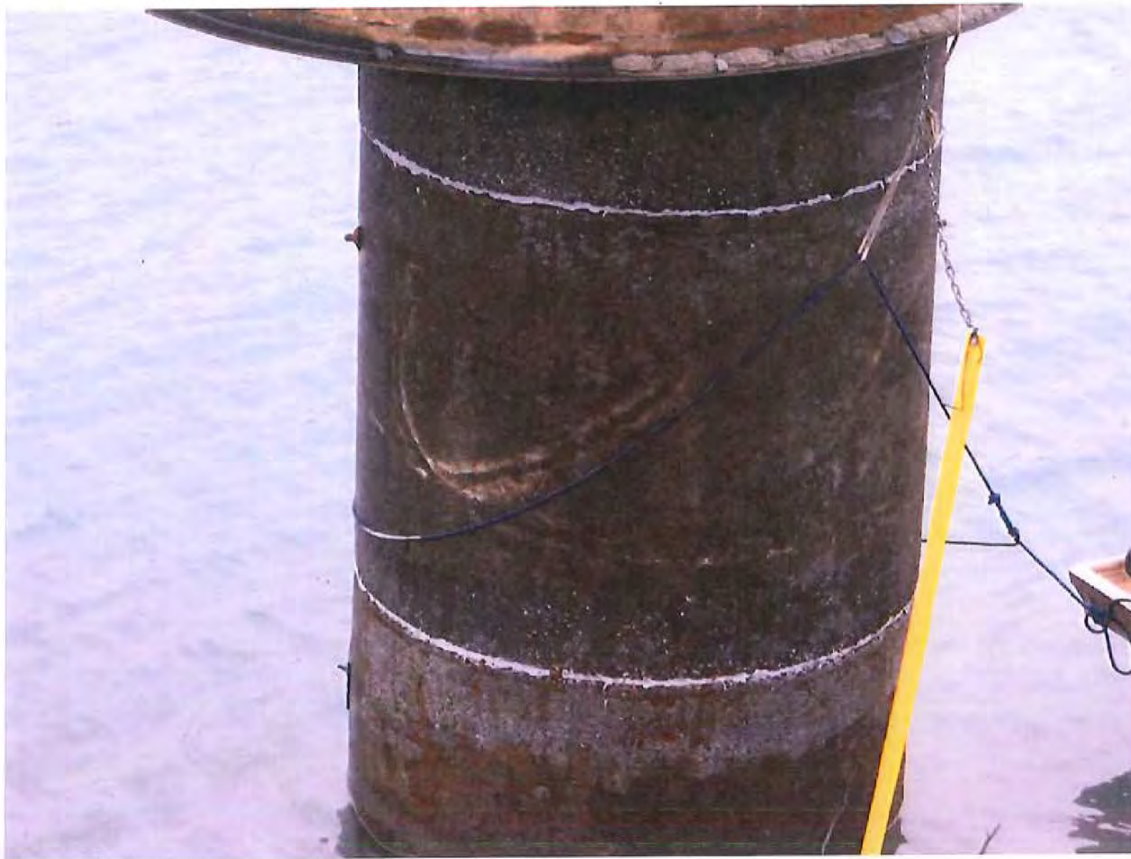
Photograph 14. 3/19/14 photograph of new grout on CAPE FEAR coal ash basin riser.

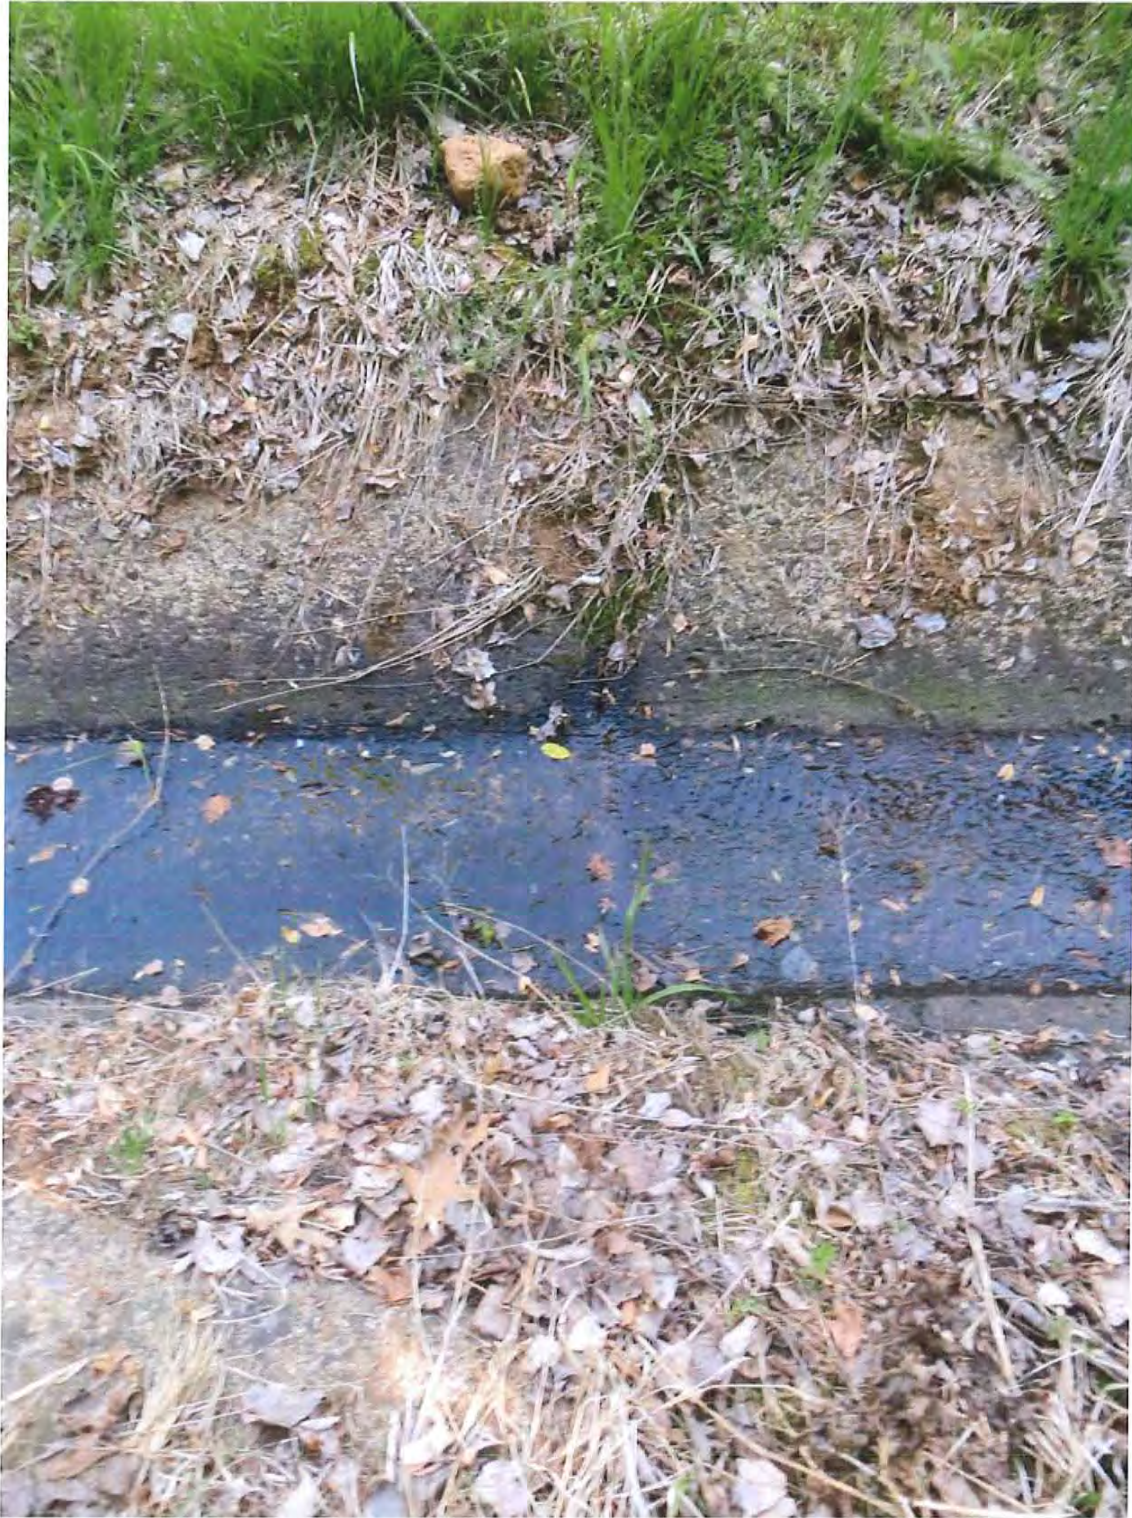
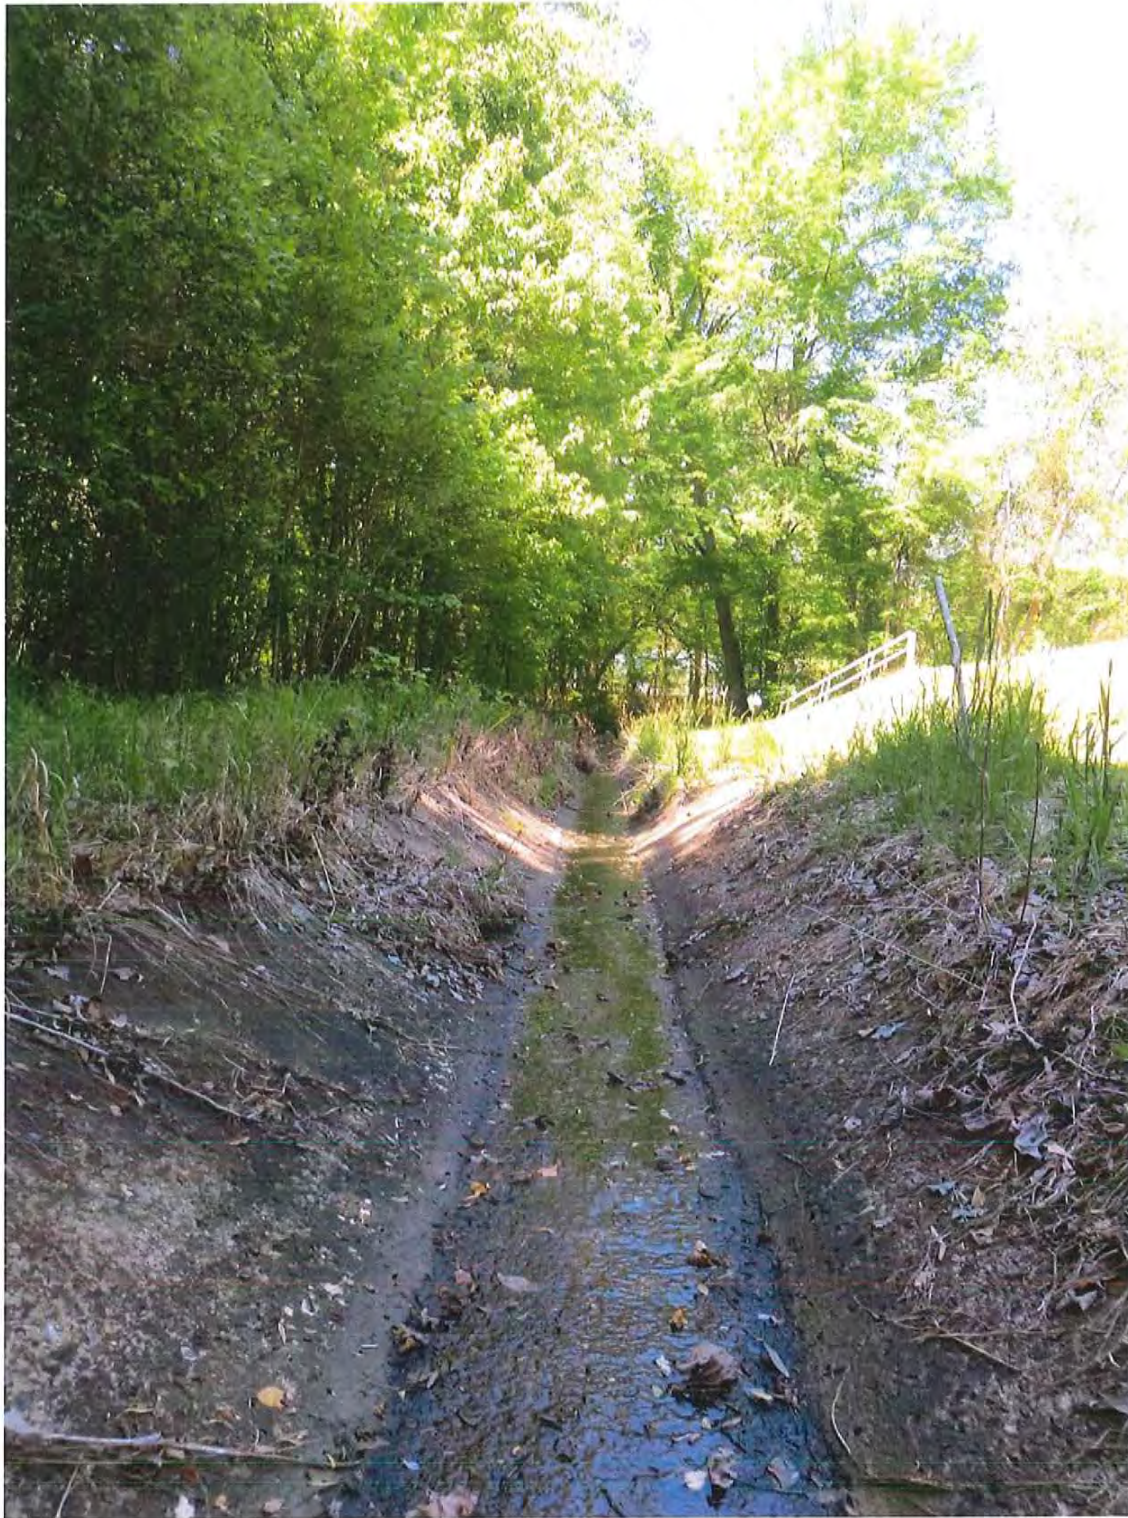
Photograph 17. Photograph of RIVERBEND Seep 12.

155. Unpermitted discharges, in violation of the applicable NPDES permit, occurred at RIVERBEND from at least November 8, 2012, through December 30, 2014.
